## LAYING THE FOUNDATIONS OF QUALITY: IMPLEMENTING A RESIDENTIAL CONSTRUCTION FRAMEWORK

### Abstract

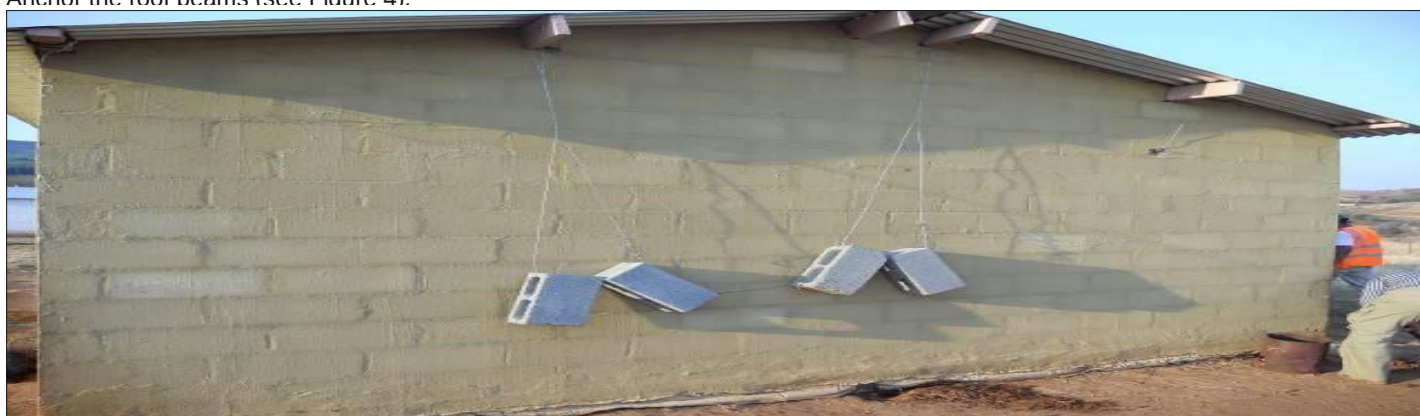
**Figure 4** : Typical roof anchoring system used for low-income houses

Of further interest to observe is the comparison of the quality of building elements of the houses. The building elements and the sub-elements associated with these elements were defined in Figure 2 and Table 2. Each building element has a score, and when aggregated with other elements, it gives an overall score for the house. For the low-income houses, the average quality score for the roofs and walls was 55% and 65%, respectively. This was not surprising, as most of the corrugated (IBR) roof sheets commonly used for low-income houses were torn, and as a result, the roofs were leaking within six months. Some of the roofs had boulders on top to prevent them from wind uplift, or cement blocks were used to

Anchor the roof beams (see Figure 4).
