# **A FRAMEWORK FOR EVALUATING RESIDENTIAL CONSTRUCTION QUALITY IN SOUTH AFRICA**

**Lungile Sipho Dlamini**

Department of Civil Engineering, University of Johannesburg, Doornfontein Campus, Johannesburg, South Africa.

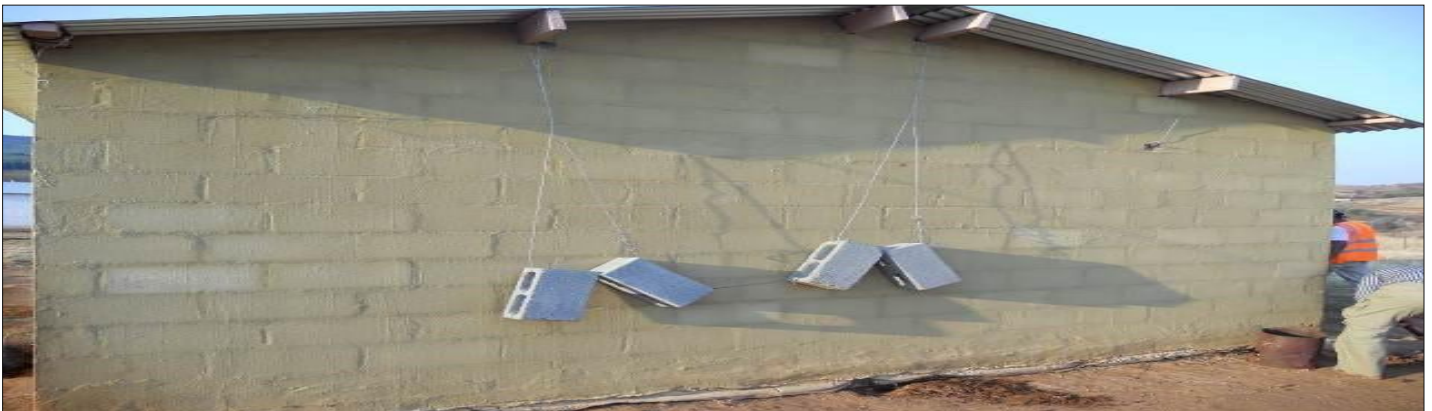
**Figure 4** : Typical roof anchoring system used for low-income houses

Of further interest to observe is the comparison of the quality of building elements of the houses. The building elements and the sub-elements associated with these elements were defined in Figure 2 and Table 2. Each building element has a score, and when aggregated with other elements, it gives an overall score for the house. For the low-income houses, the average quality score for the roofs and walls was 55% and 65%, respectively. This was not surprising, as most of the corrugated (IBR) roof sheets commonly used for low-income houses were torn, and as a result, the roofs were leaking within six months. Some of the roofs had boulders on top to prevent them from wind uplift, or cement blocks were used to

Anchor the roof beams (see Figure 4).
