# ENHANCING RESIDENTIAL BUILDING STANDARDS: A SOUTH AFRICAN FRAMEWORK FOR CONSTRUCTION QUALITY EVALUATION

## Abstract

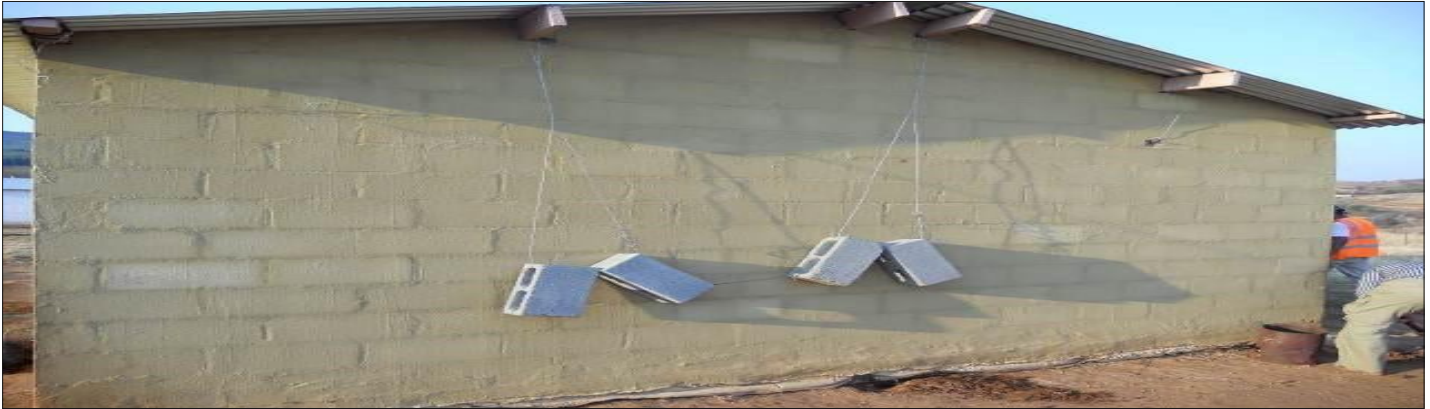
Figure 4 : Typical roof anchoring system used for low-income houses

low-income houses, the average quality score for the roofs and walls was 55% and 65%, respectively. This was not surprising, as most of the corrugated (IBR) roof sheets commonly used for low-income houses were torn, and as a result, the roofs were leaking within six months. Some of the roofs had boulders on top to prevent them from wind uplift, or cement blocks were used to

Anchor the roof beams (see Figure 4).

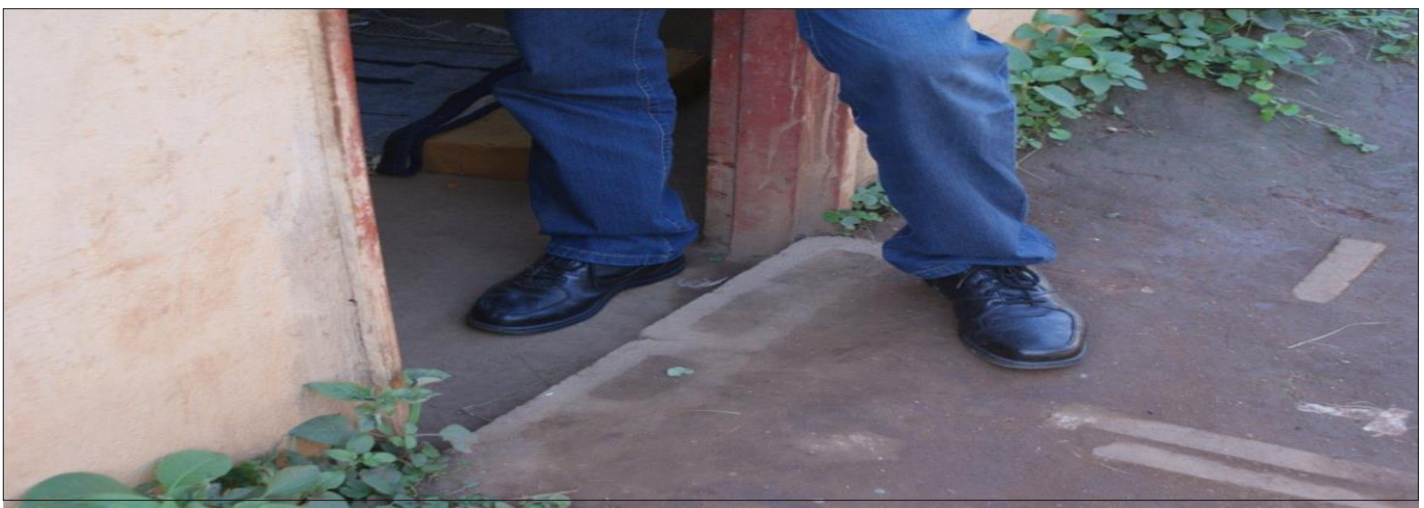
Figure 7: Example of poor substructure in low-income houses

plotted below the regression line. Such type of correlation graph is useful where the project has many subcontractors. The graphs would enable training interventions that are required and identify which aspects of the project should be addressed, in order to obtain a better quality house. Figure 7 presents a typical example of a poor sub-structure (floor) construction. The image shows that the floor level does not meet the minimum standard, which stipulates that the floor level must be at least 150 mm above the natural ground level. In the event of rain, the house is likely to flood, compromising the integrity of the foundation, the house, as well as the health and safety conditions of the occupants. Therefore, a developmental strategy for this homebuilder would be on the basic understanding of the impact of storm water on top structure performance. A similar comparison of walls and roofs for the same project suggests that the relative construction qualities of both elements are of a similar order of magnitude.
